***Evaluation of a Vehicle-Actuated Warning System for Stop-Controlled
Intersections Having Limited Sight Distances***

***Report for the 2001 International Conference on Rural Advanced Technology and
Transportation Systems***

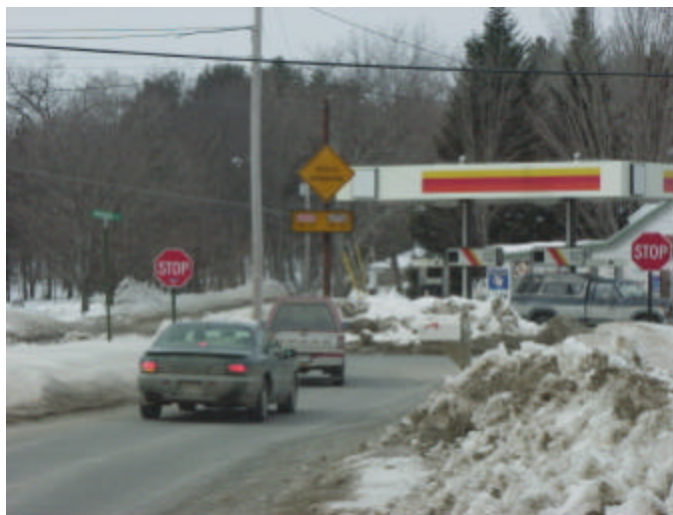
Type 1 Sign

In concept, the prototype system provides vehicle detection and warnings at all legs of an intersection. Depending on the individual site characteristics, portions of the system design could be deleted for any particular site. For example, on some sites, warning signs might be eliminated on one or both legs of the mainline. On another site perhaps only one of the stop-controlled legs would be treated. Soon after the prototype design was finalized, the first site was chosen for treatment.

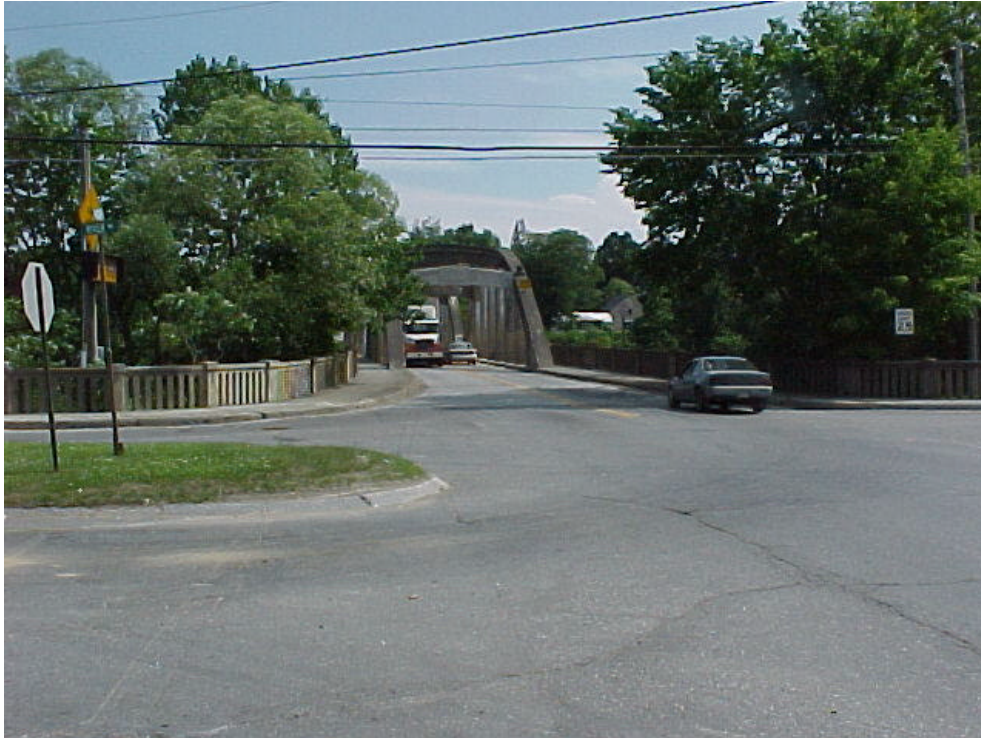
The site is a rural intersection along Rt. 201A in Norridgewock, Maine. At that site, a multi-arch concrete bridge with large structural concrete columns and railings limited site distances

in one direction at a stop-controlled intersection. The following photo shows the site conditions.

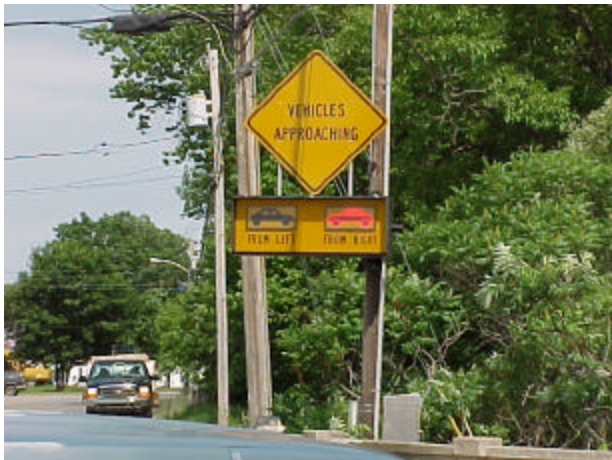
The photograph above shows the sign opposite Sophie May Lane (see image on next page) in its active condition. At right, the sign is inactive.

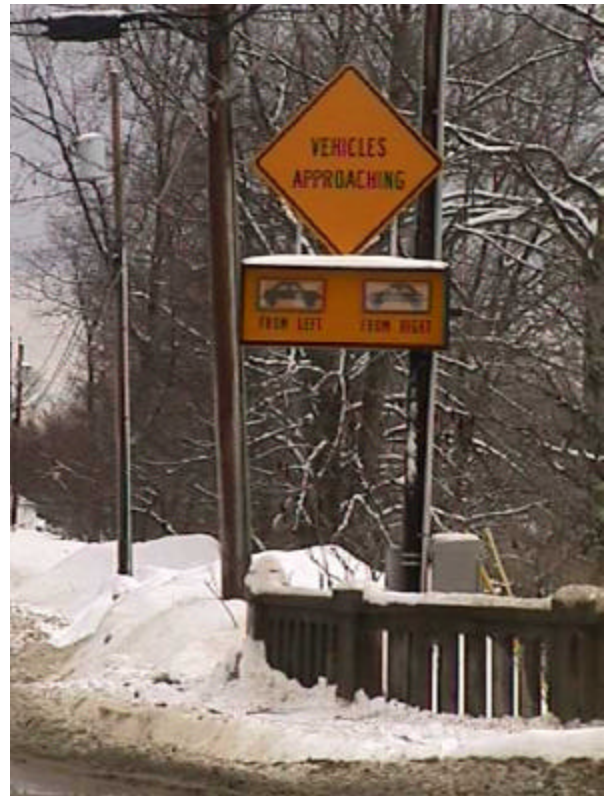
At right is an aerial photograph of the intersection and the warning sign locations.

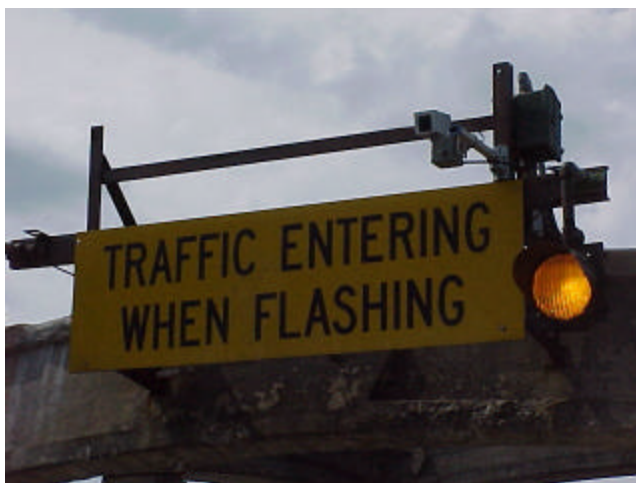
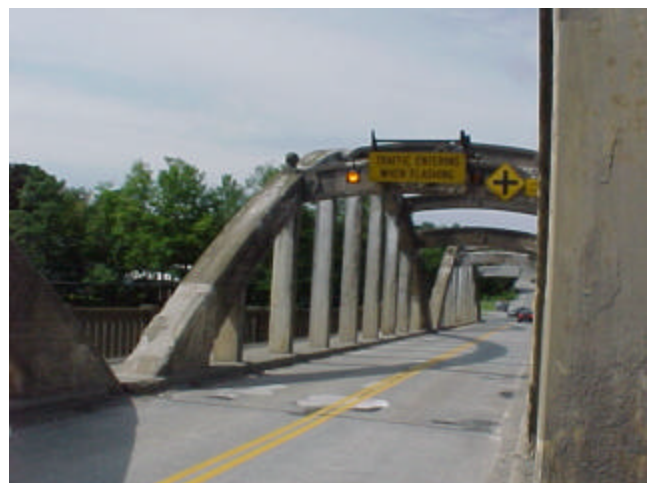
One complication at the chosen site is that a traffic-actuated warning sign had been in place for many years. The mainline warning sign is shown in the two photos below. In a typical installation a different sign design would be used on the mainline. However, it was felt that the existing sign could be used so that a study of the mainline warning message only could be conducted prior to installation of the new system. The existing sign was retained in the new system. The results of the two traffic conflict studies are discussed in turn later in this report.
